## **Demonstration and Validation of Materials for Corrosion-Resistant Fencing and Guard Railings in Aggressive Climates**

Final Report on Project F09-AR02

Christopher Olaes, Richard G. Lampo, and Lawrence Clark

October 2015

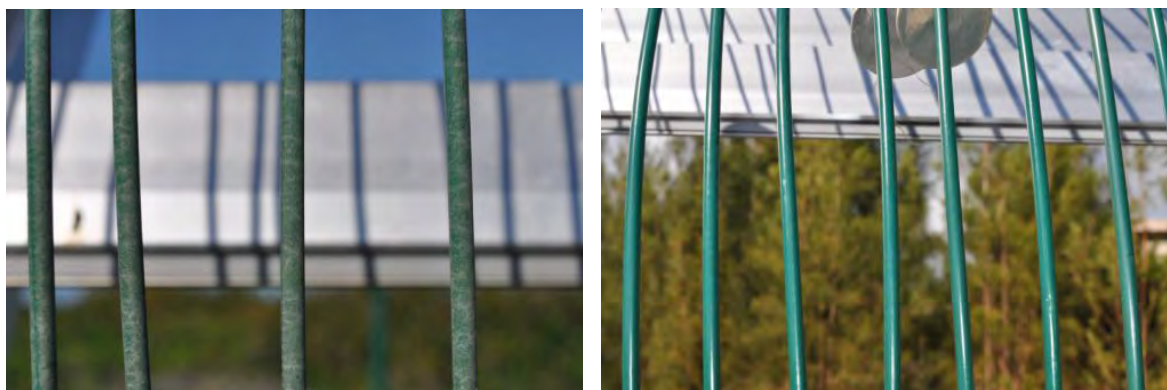
Figure 18. Standard PVC coated galvanized wire coupon at FRF (left) and KTA (right) after 6 months of exposure.

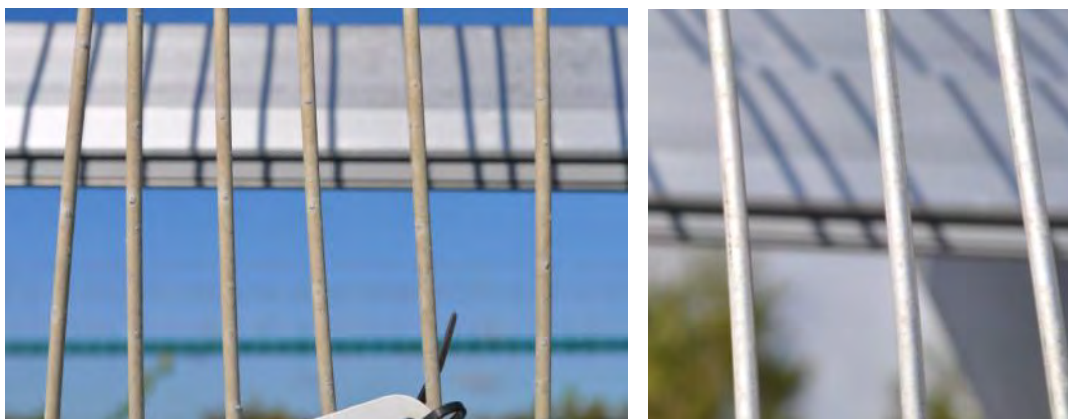
Figure 19. Aluminum wire coupon at FRF (left) and KTA (right) after 6 months of exposure.

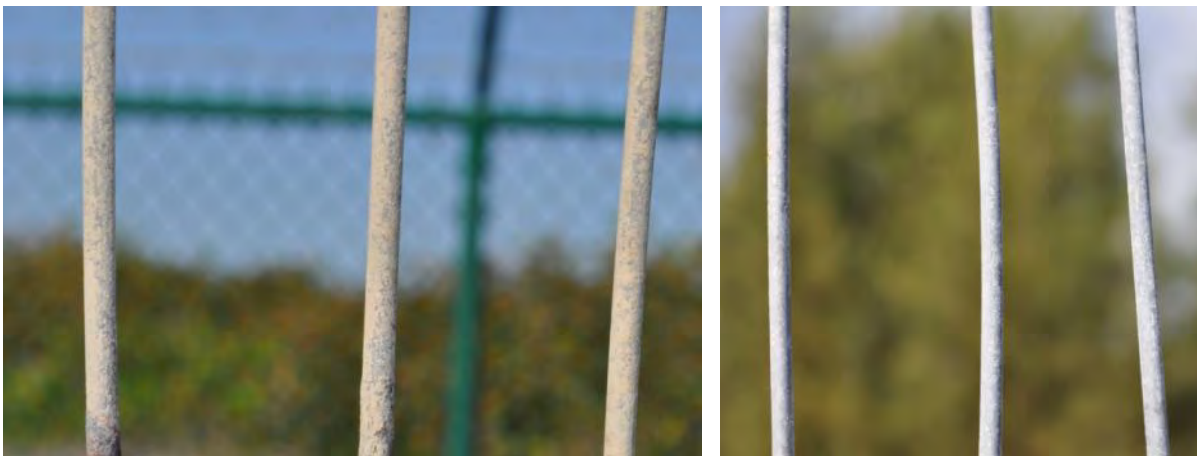
Figure 21. Galvan wire coupon at FRF (left) and KTA (right) after 6 months of exposure

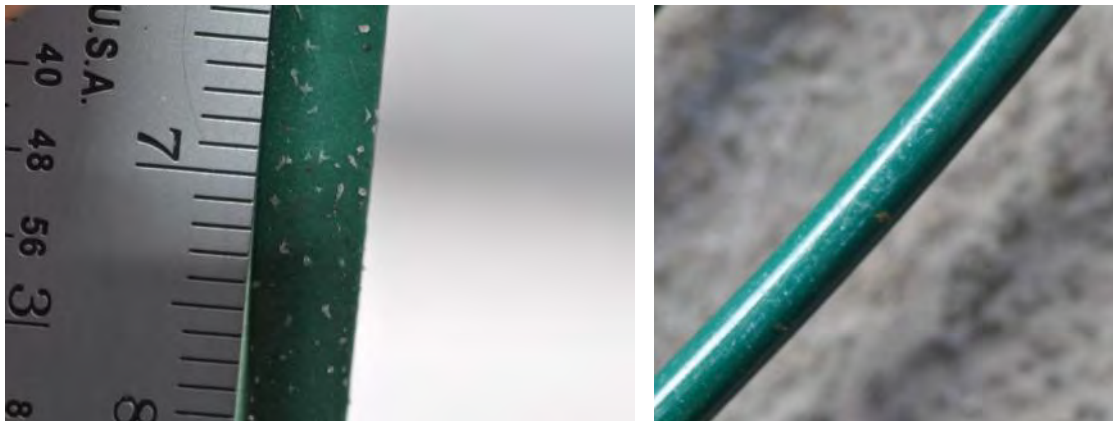
Figure 22. Standard PVC coated galvanized steel wire coupon at FRF (left) and KTA (right) after 12 months of exposure.

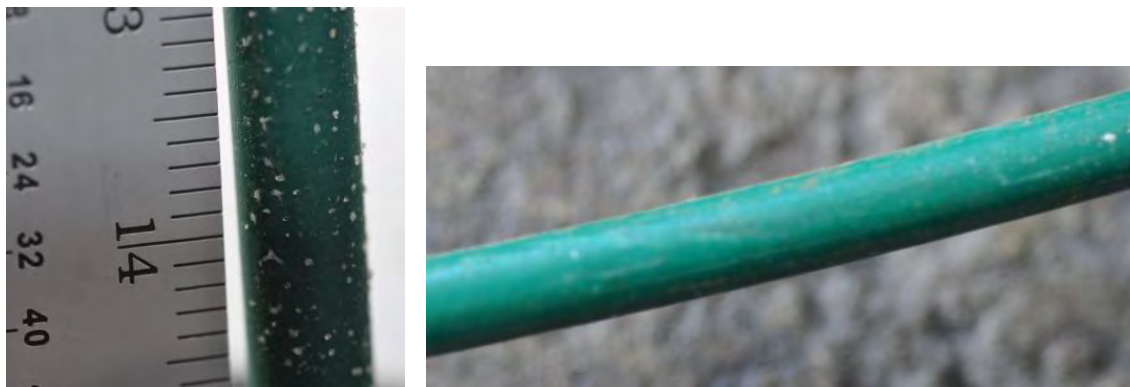
Figure 25. Fuse bonded PVC coated wire coupon at FRF (left) and KTA (right) after 12 months of exposure.

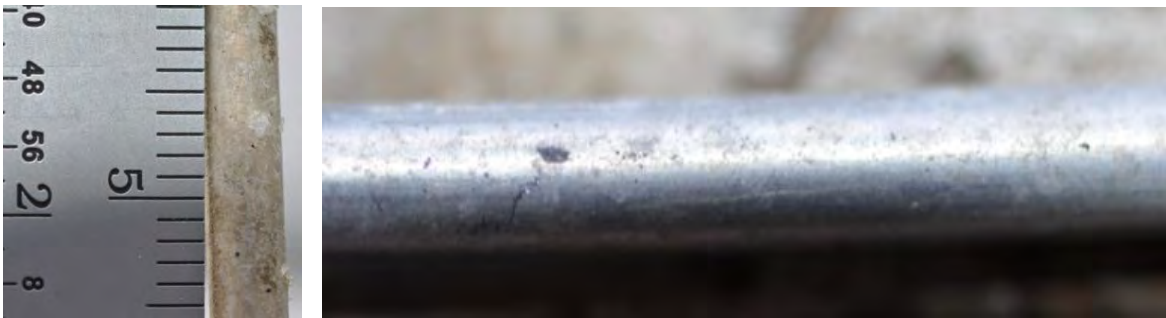
Figure 26. Aluminum wire coupon at the FRF (left) and KTA (right) after 12 months of exposure.

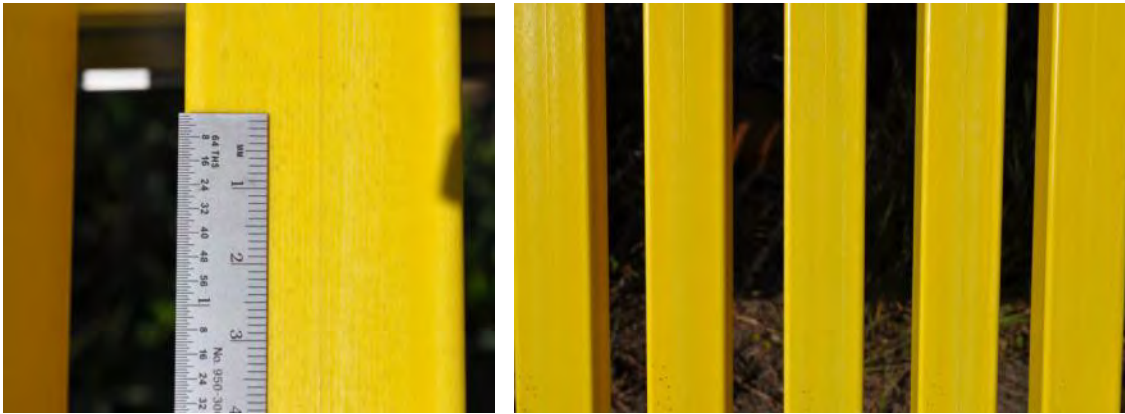
months of exposure. The FRP railings did not show signs of degradation until 6 months of exposure. The sides of railing specimens that face the sun the longest during the day were affected by color fading.

Figure 29. FRP railing coupon at FRF (left) and KTA (right) after 6 months of exposure.

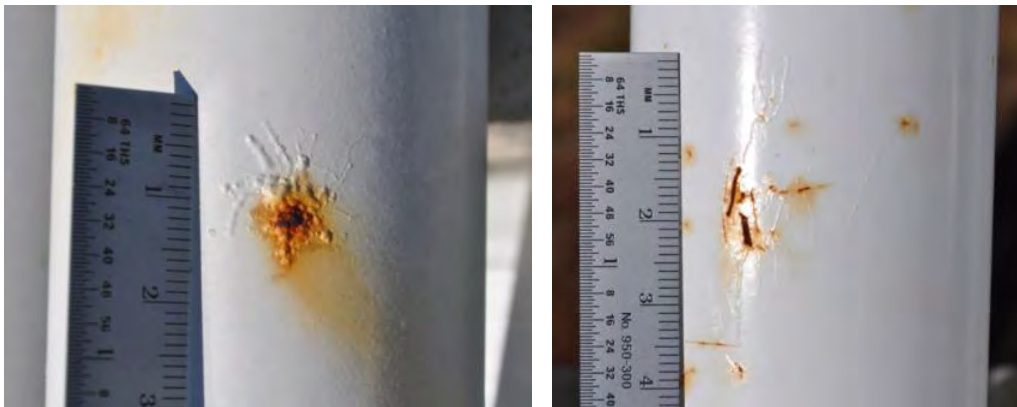
Figure 30. Coated steel railing coupon at FRF (left) and KTA (right) after 6 months of exposure.

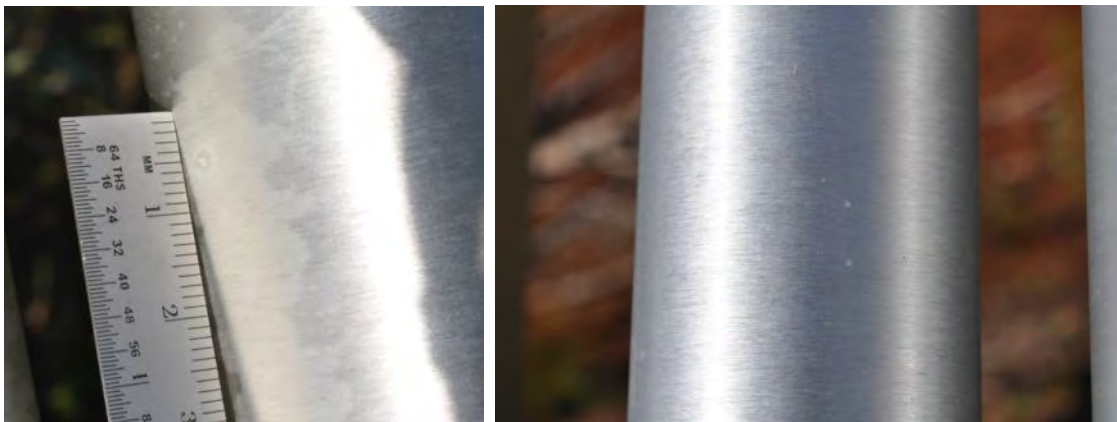
Figure 32. Aluminum railing coupon at FRF (left) and KTA (right) after 6 months of exposure.

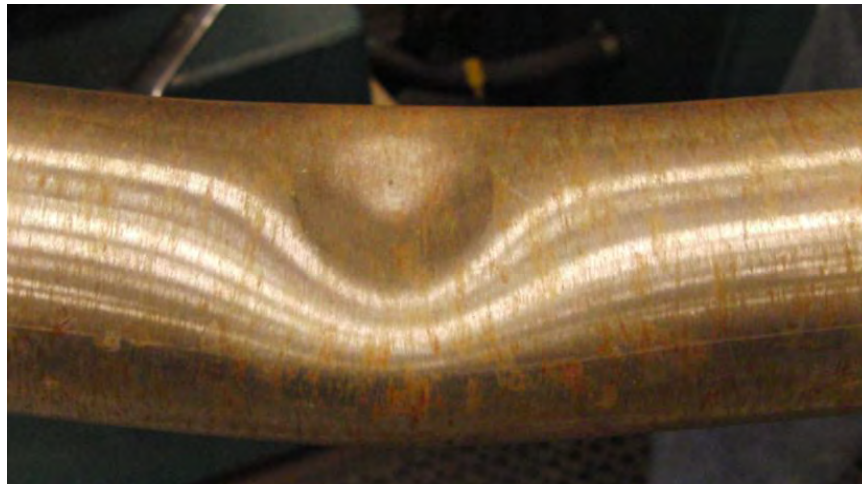
Figure 46 shows a typical graph of steel pipe deformation as a flexure load is applied. It was found that the longitudinal shape of the pipe remained rigid and the circular cross section collapsed before the pipe began to flex, as seen in Figure 47. This same behavior was not observed in the aluminum or FRP railing specimens. The aluminum specimens were relatively ductile in comparison with steel and stainless steel, and therefore began to deform in both the cross section and longitudinally at the same time. The FRP railing had a square cross section and is not very ductile compared to either steel or aluminum, so its failure was different than the metallic specimens. Figure 48 – Figure 50 represent the change in the tangent modulus throughout the exposure period for each test site. More data can be found in Appendix E.

Figure 47. Cross sectional collapse of a stainless steel pipe under flexure testing.

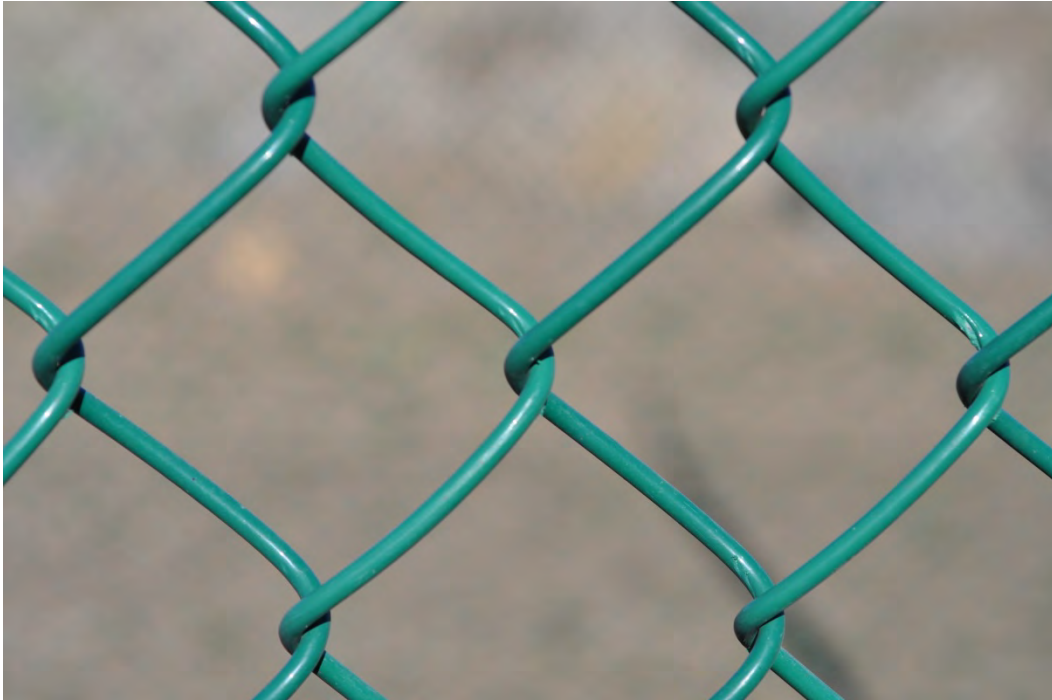
Figure A7. Fuse-bonded PVC after 6 months exposure.

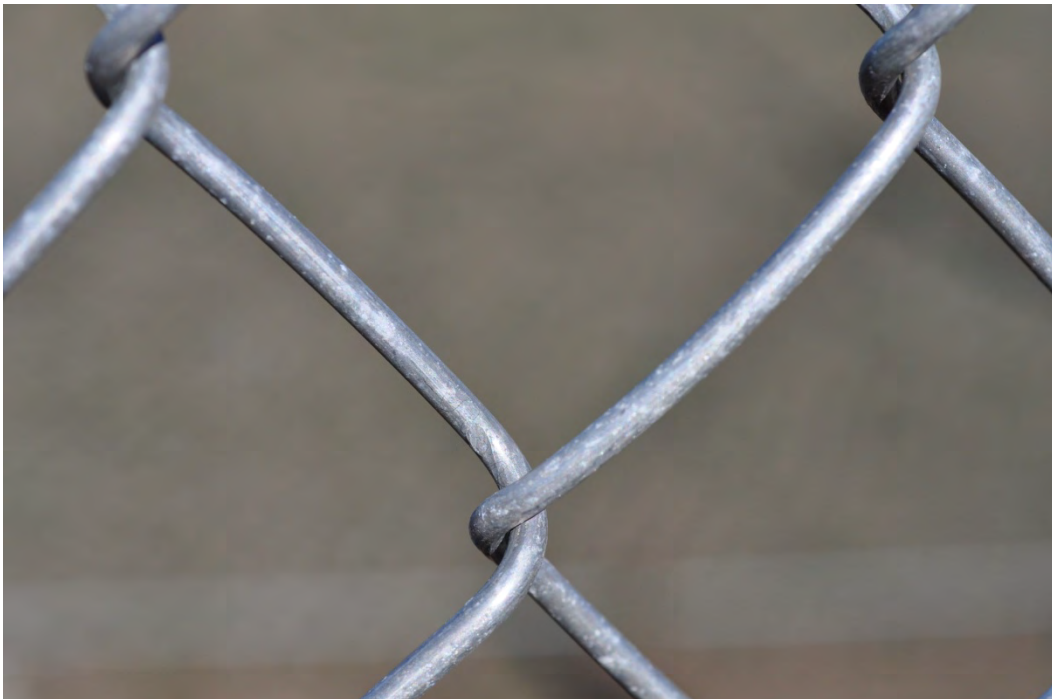
Figure A8. Stainless steel after 6 months exposure.

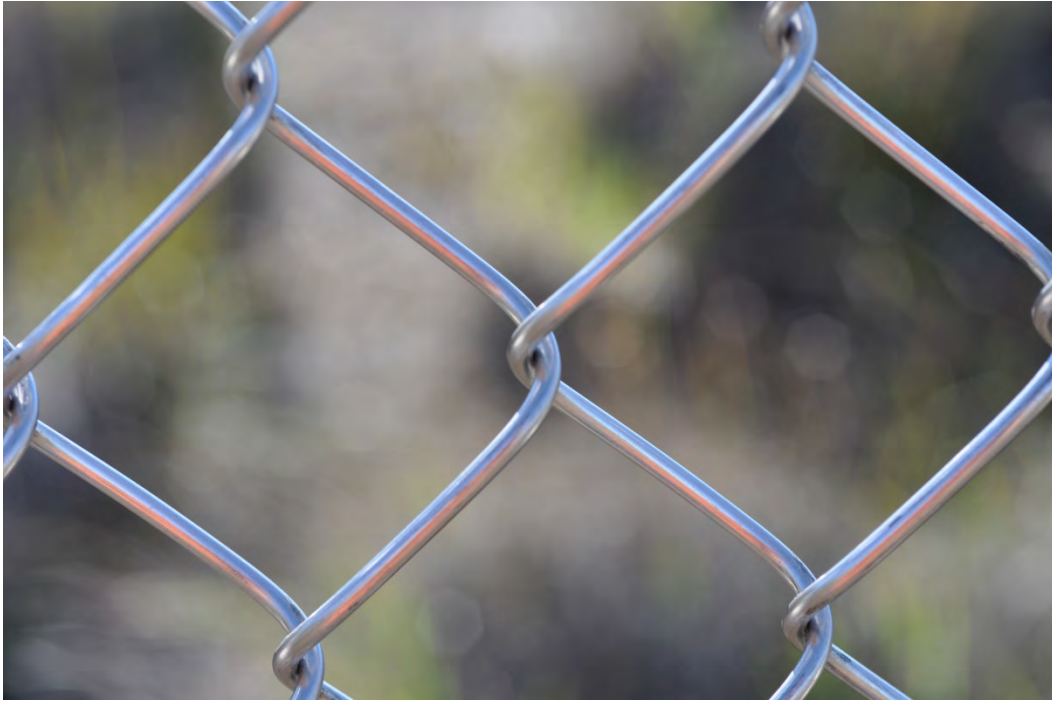
Figure A9. Aluminum after 6 months exposure.

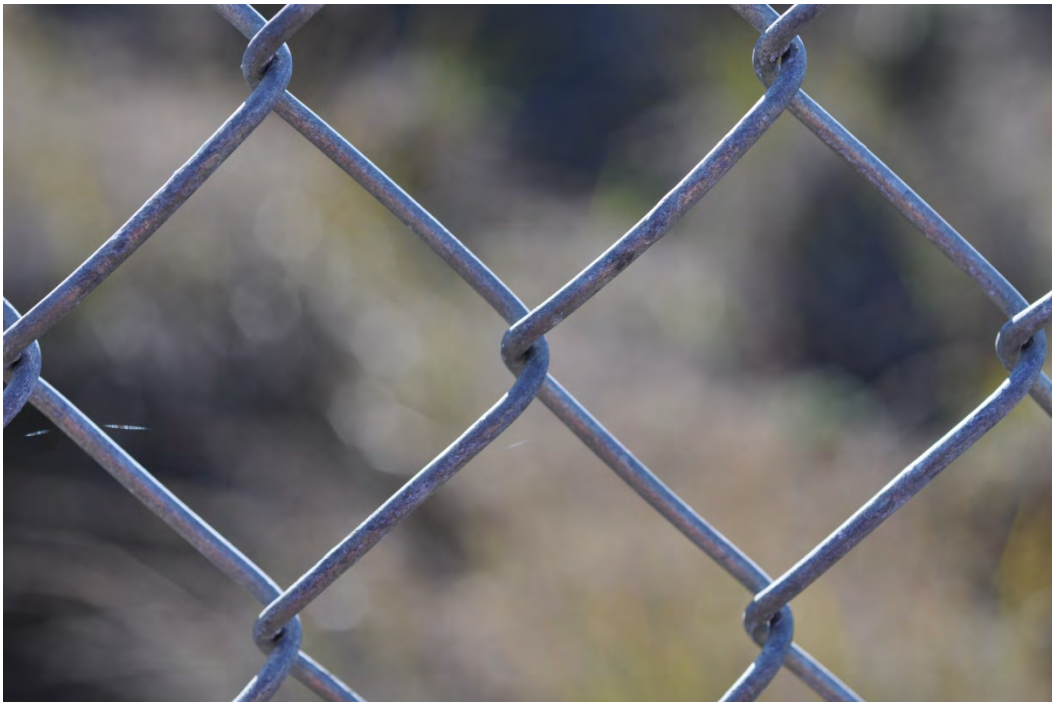
Figure A10. Galvanized steel after 6 months exposure.

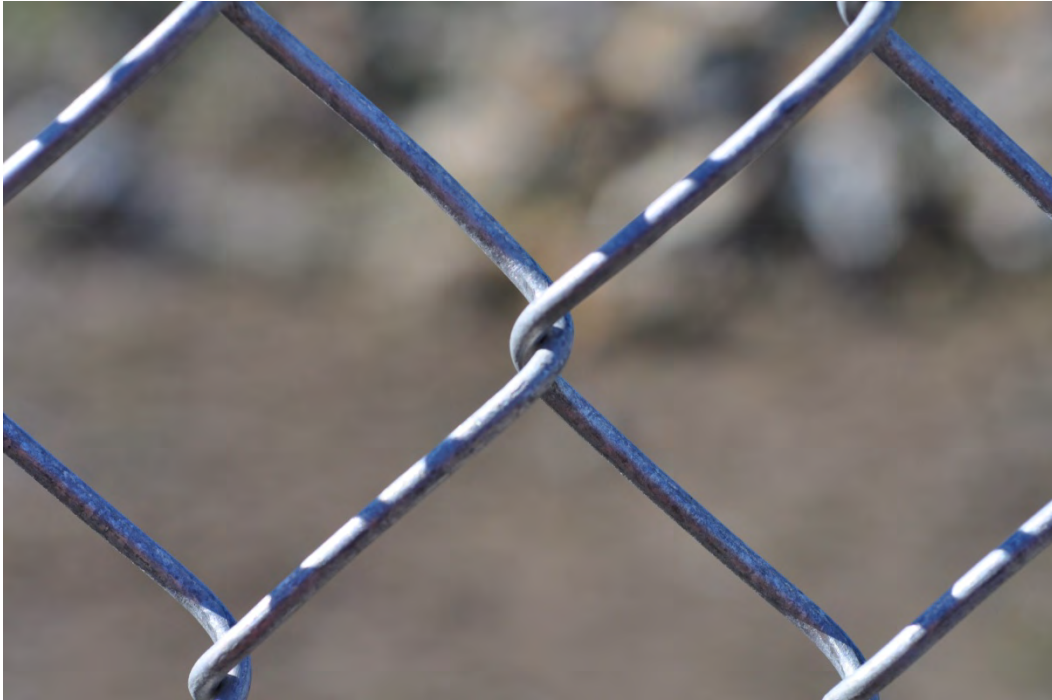
Figure A11. Aluminized after 6 months exposure.

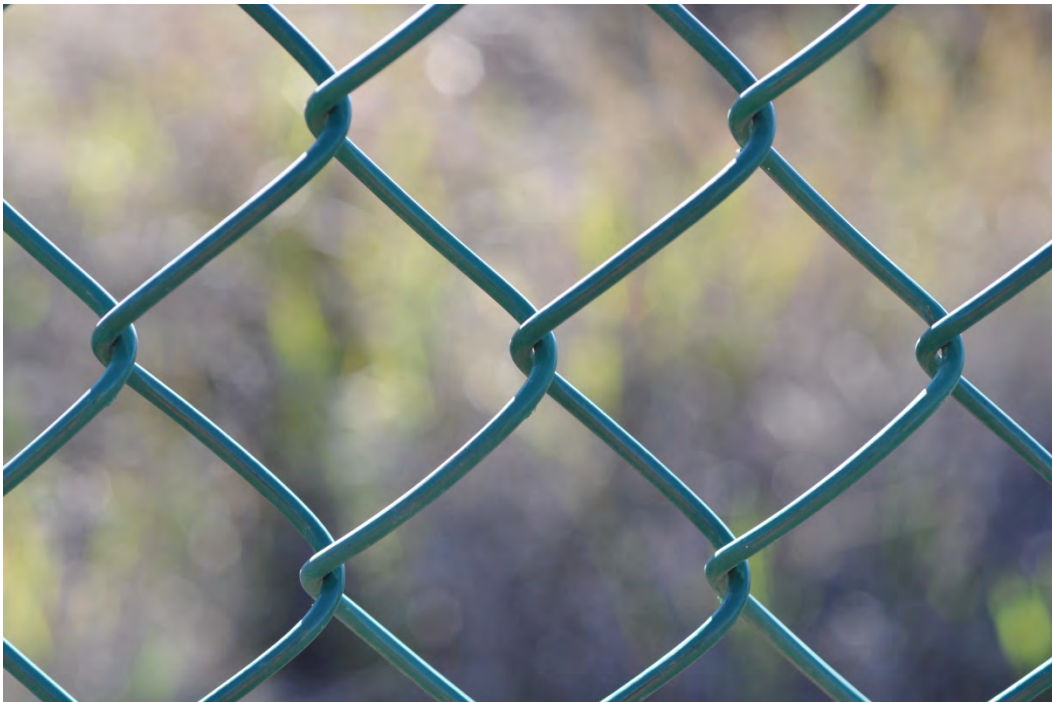
Figure A12. Standard PVC after 6 months exposure.

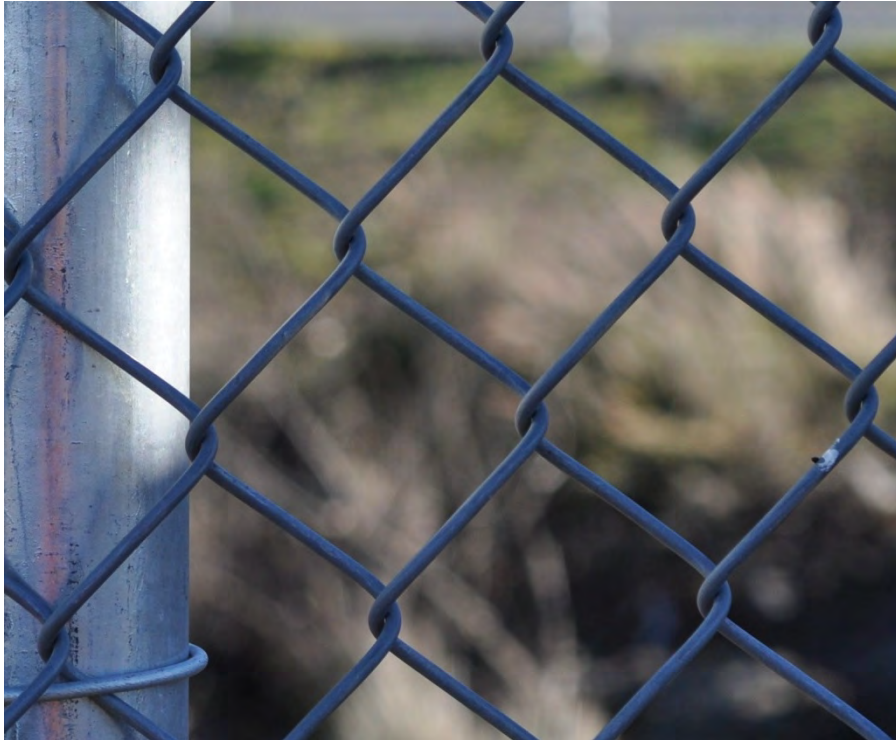
Figure A13. Galfan PVC after 6 months exposure.

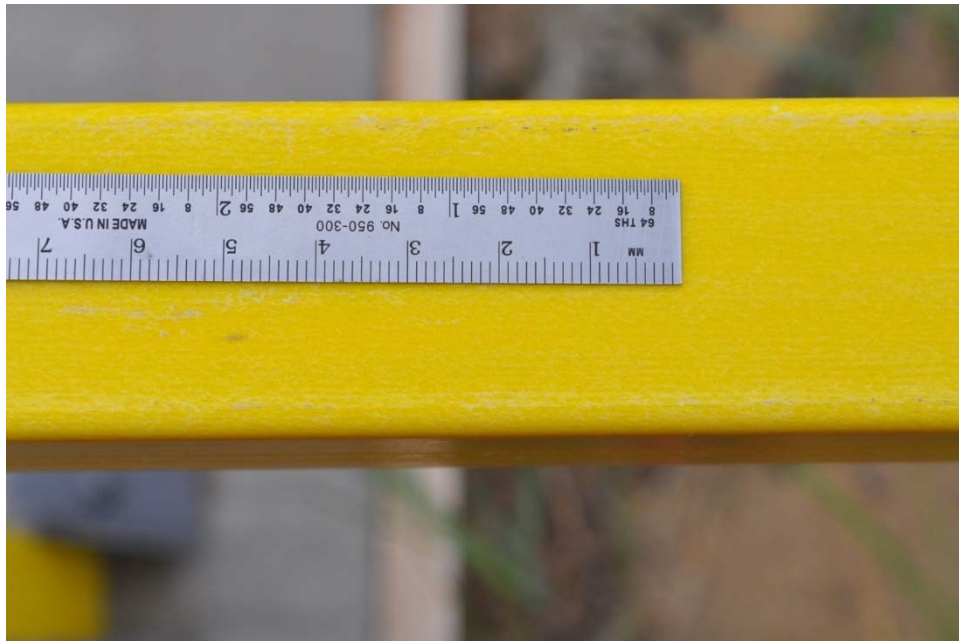
Figure B1. FRP Railing Coupon

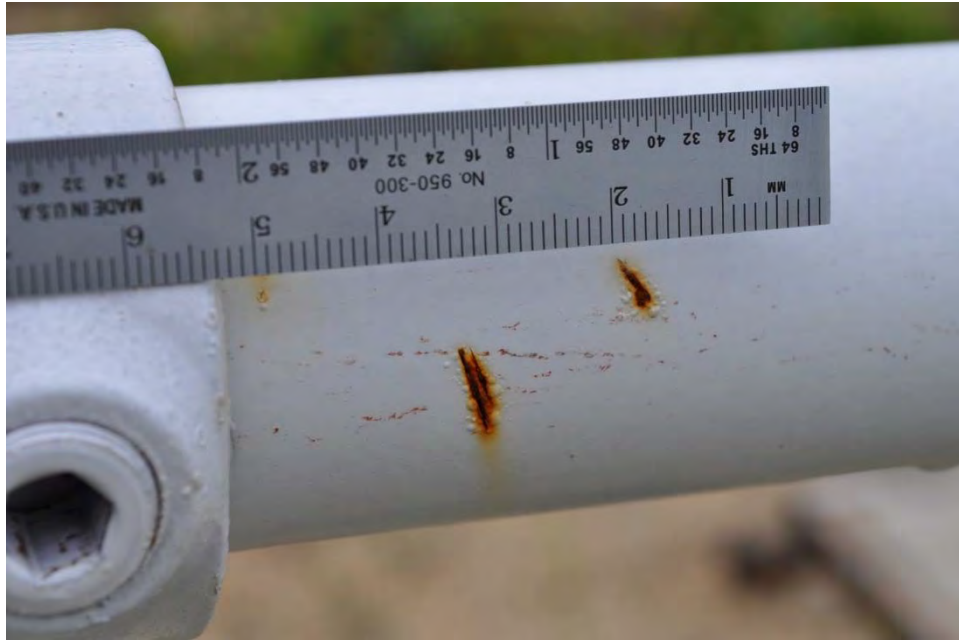
Figure B3. Coated Steel Coupon

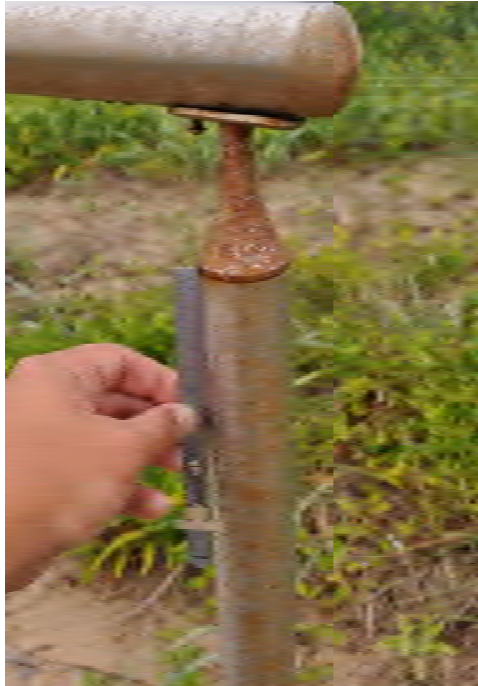
Figure B5. Stainless Steel Coupon

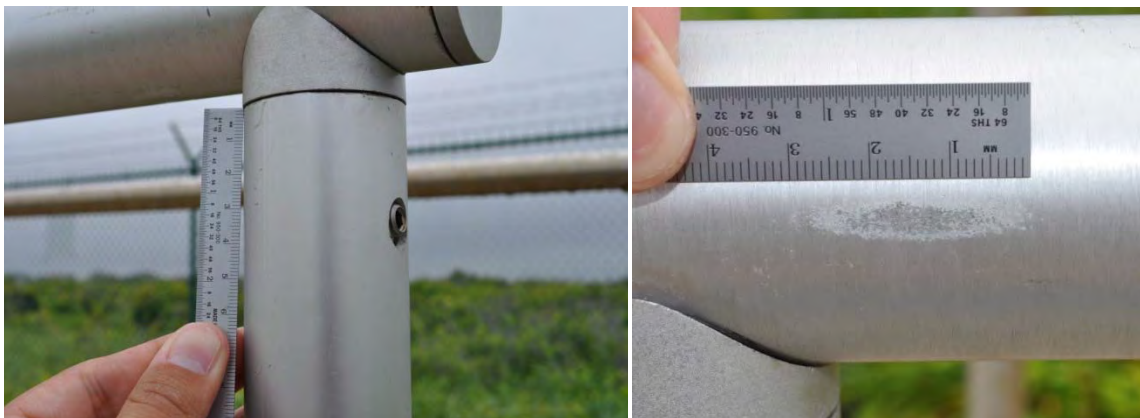
Figure B7. Aluminum Railing Coupon

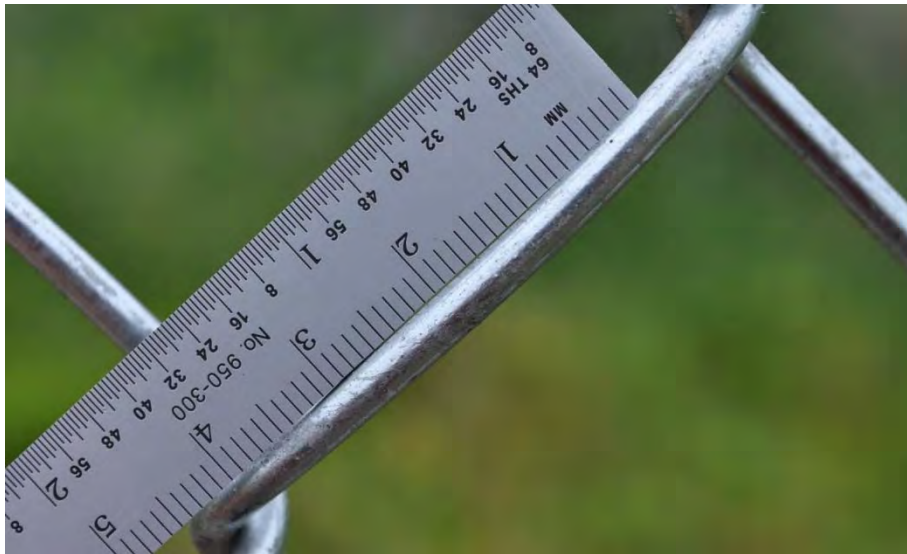
*Figure B9. Standard PVC Coated Galvanized Wire Coupon*

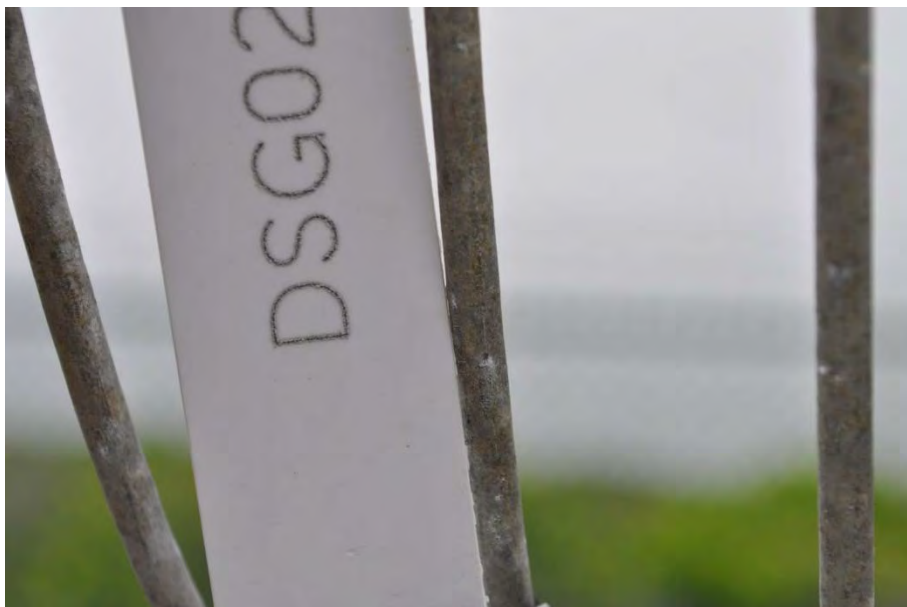
*Figure B10. Standard Galvanized Wire Fencing*

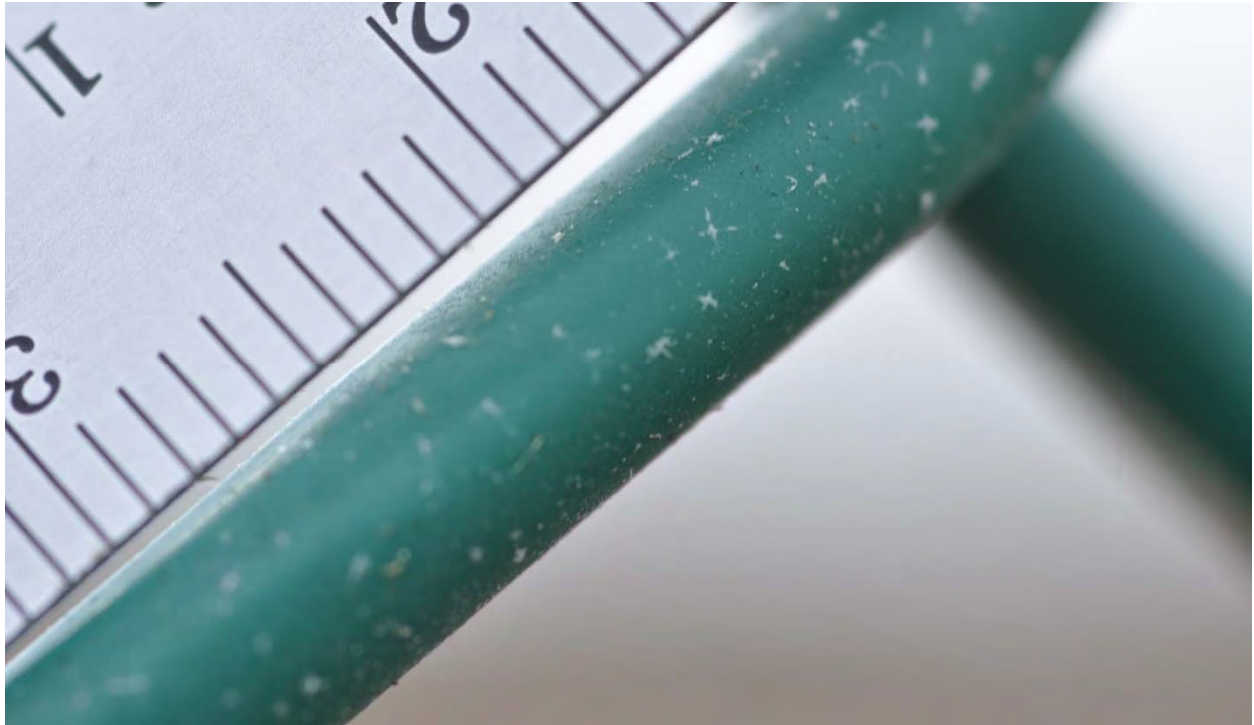
*Figure B56. Fuse Bonded PVC Coated Galvanized Wire Fencing*

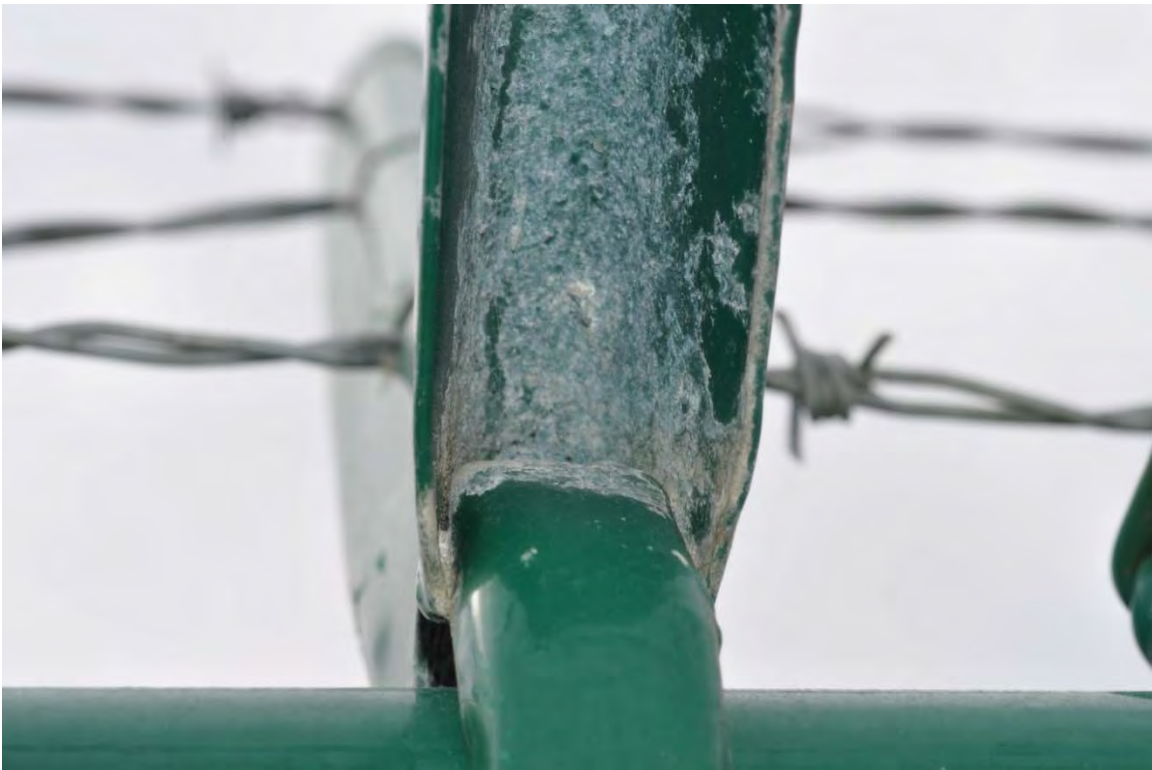
*Figure B63. Fuse Bonded PVC Coated Galvanized Wire Fencing Hardware*

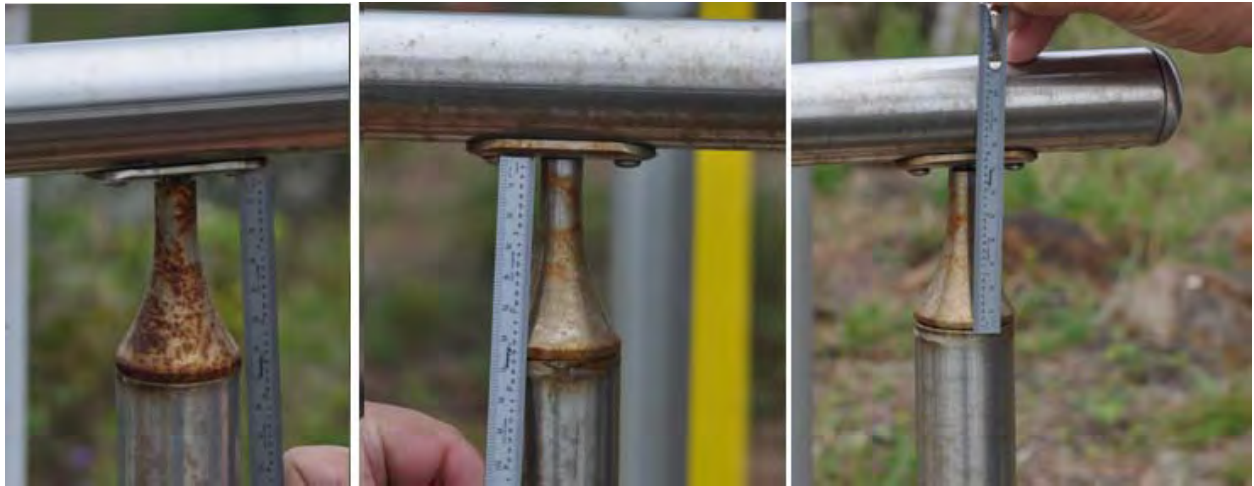
<b>Railing Coupons</b>				
	Stainless Steel	50%	Oxidation	Surface oxidation has discolored the material
	Aluminum	<5%	Pitting	Pitting has begun in areas where the anodize may have been damaged
	Coated Steel	10%	Rust	Rust has begun to form where the coating has failed. Discoloring of the coating due to the rust.
	FRP	0%	N/A	No visible corrosion
<b>Fabricated Railing</b>				
	Stainless Steel	80%	Oxidation	Surface oxidation has discolored the material. T-fittings show 90% surface corrosion likely due to lack of passivation.
	Aluminum	<5%	Pitting	Pitting has begun in areas where the anodize may have been damaged
	Coated Steel	10%	Rust	Rust has begun to form where the coating has failed. Discoloring of the coating due to the rust.
	FRP	0%	N/A	No visible corrosion

Figure B65. (Left) Southern most stainless steel T-fitting, (Center) center stainless steel T-fitting, (Right) northern most stainless steel T-fitting.

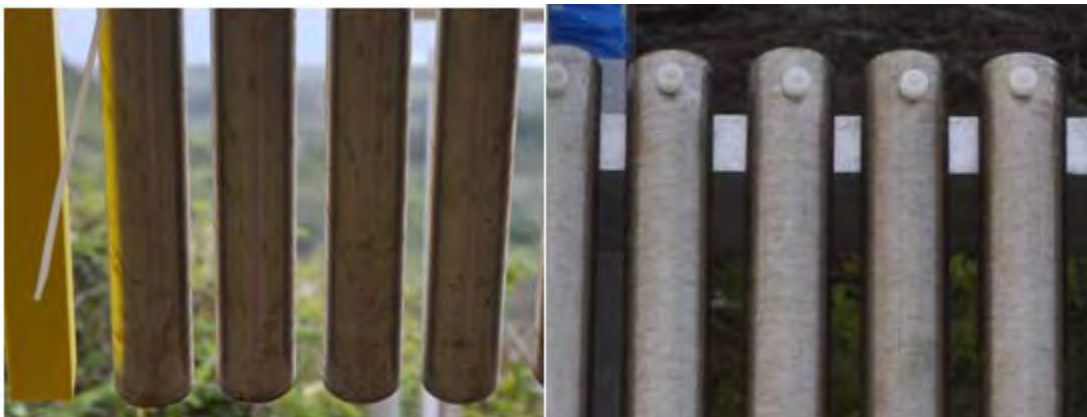
Figure B66. (Left) Stainless steel coupons facing away from the ocean; (Right) stainless steel coupons facing the Ocean.

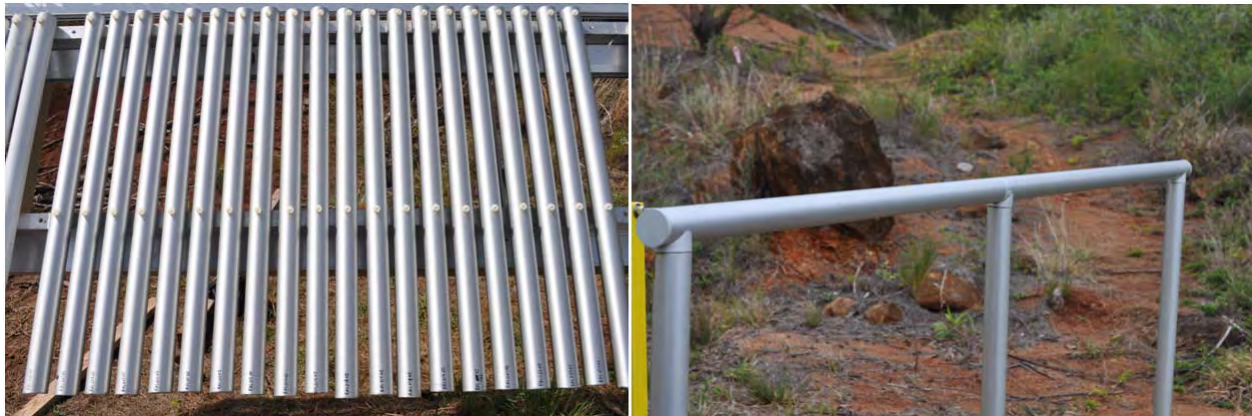
Figure B69. (Left) Aluminum railing coupons. (Right) Aluminum railing test section.

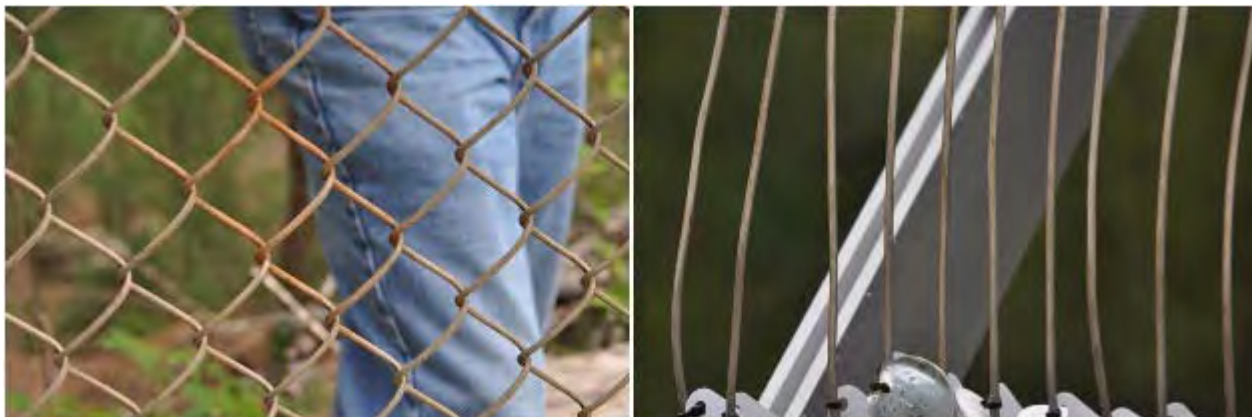
Figure B70. (Left) Stainless steel fence after 3 months exposure.  
(Right) Stainless steel wire coupons after 3 months exposure.

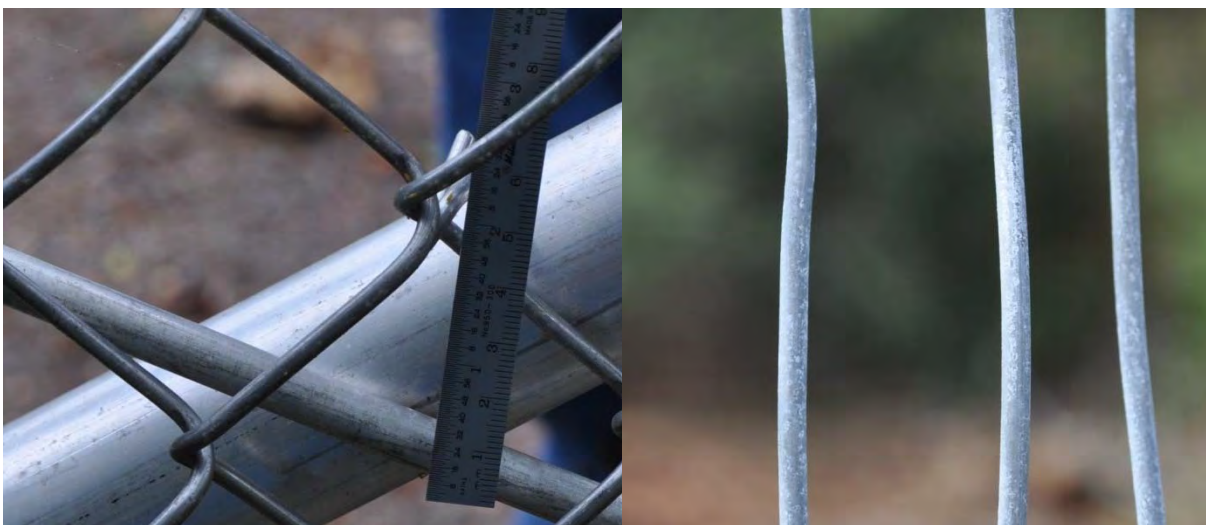
Figure B73. (Left) Galfan fabricated fencing. (Right) Galfan Wire Coupons

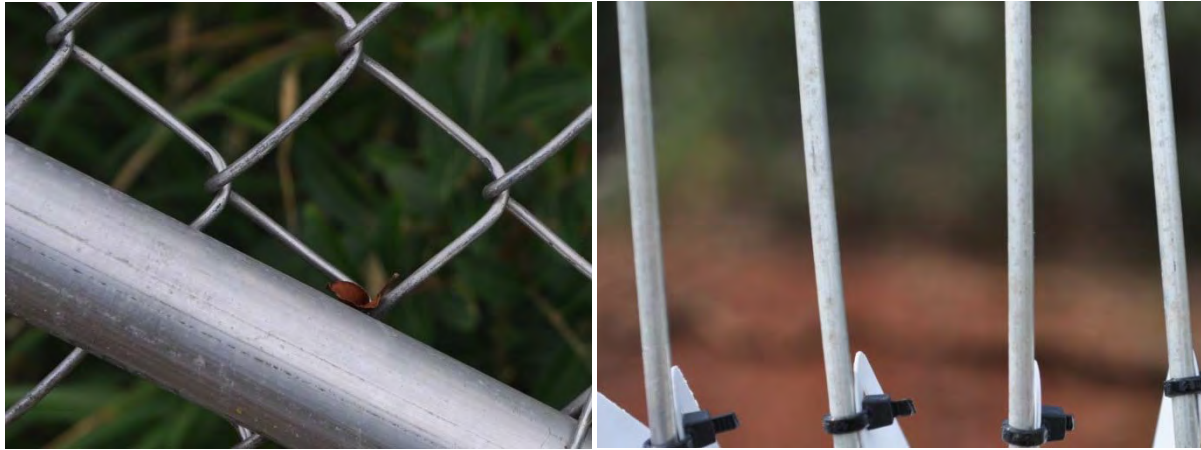
*Figure B74. (Left) Aluminum fabricated fencing. (Right) Aluminum Wire Coupons*

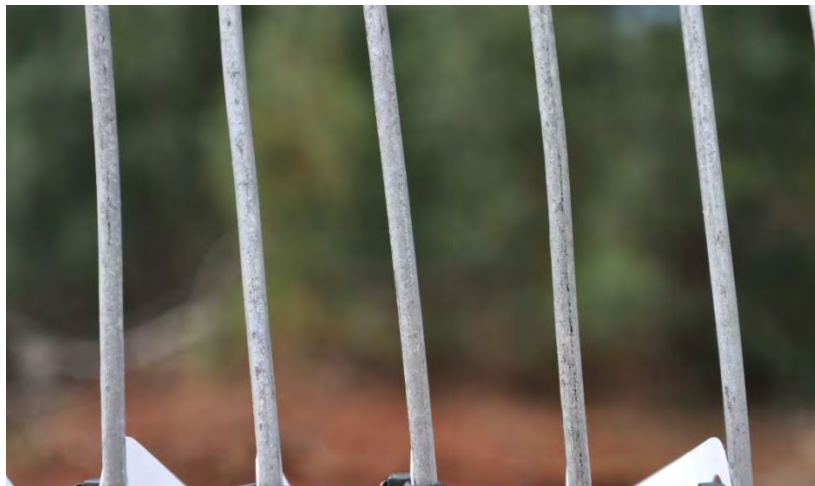
*Figure B75. Standard galvanized wire coupons*

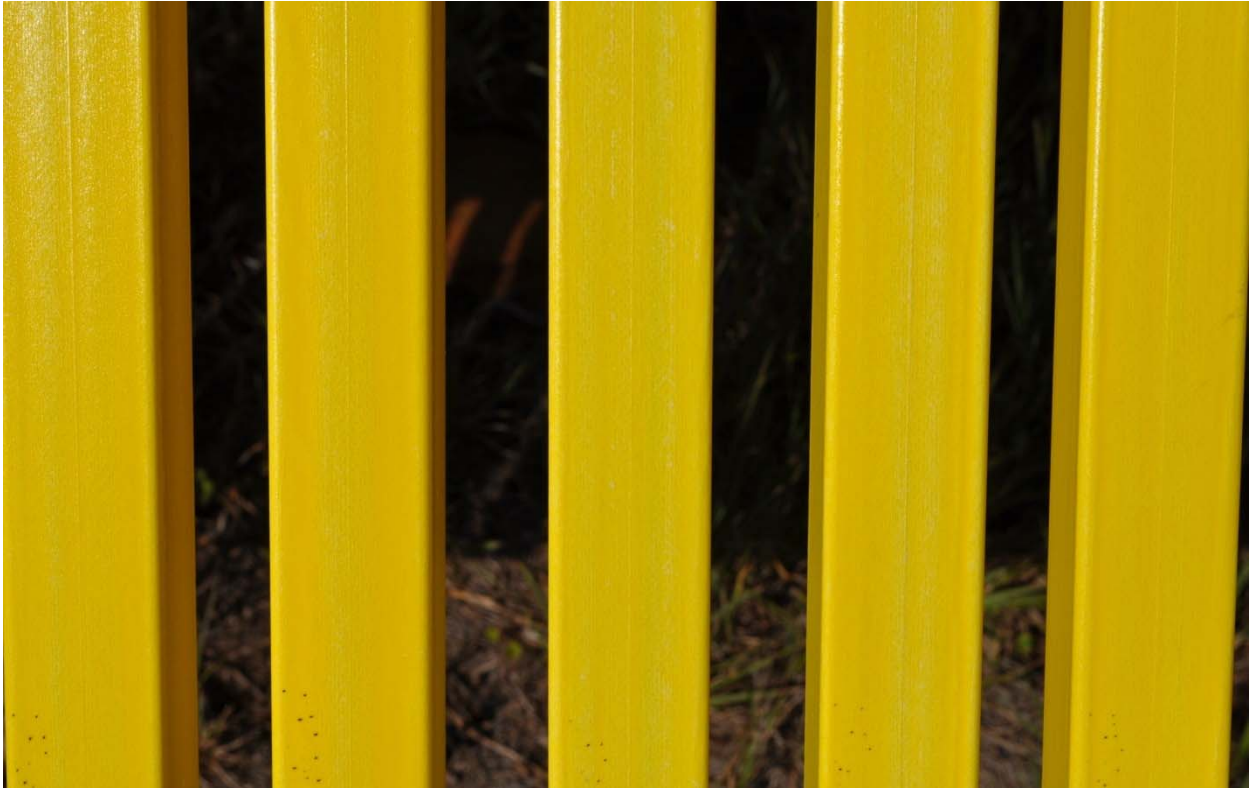
FRP	25%	UV	Discoloring due to UV exposure on the face of the railing that faces the sun

*Figure B77. FRP Railing Coupon*

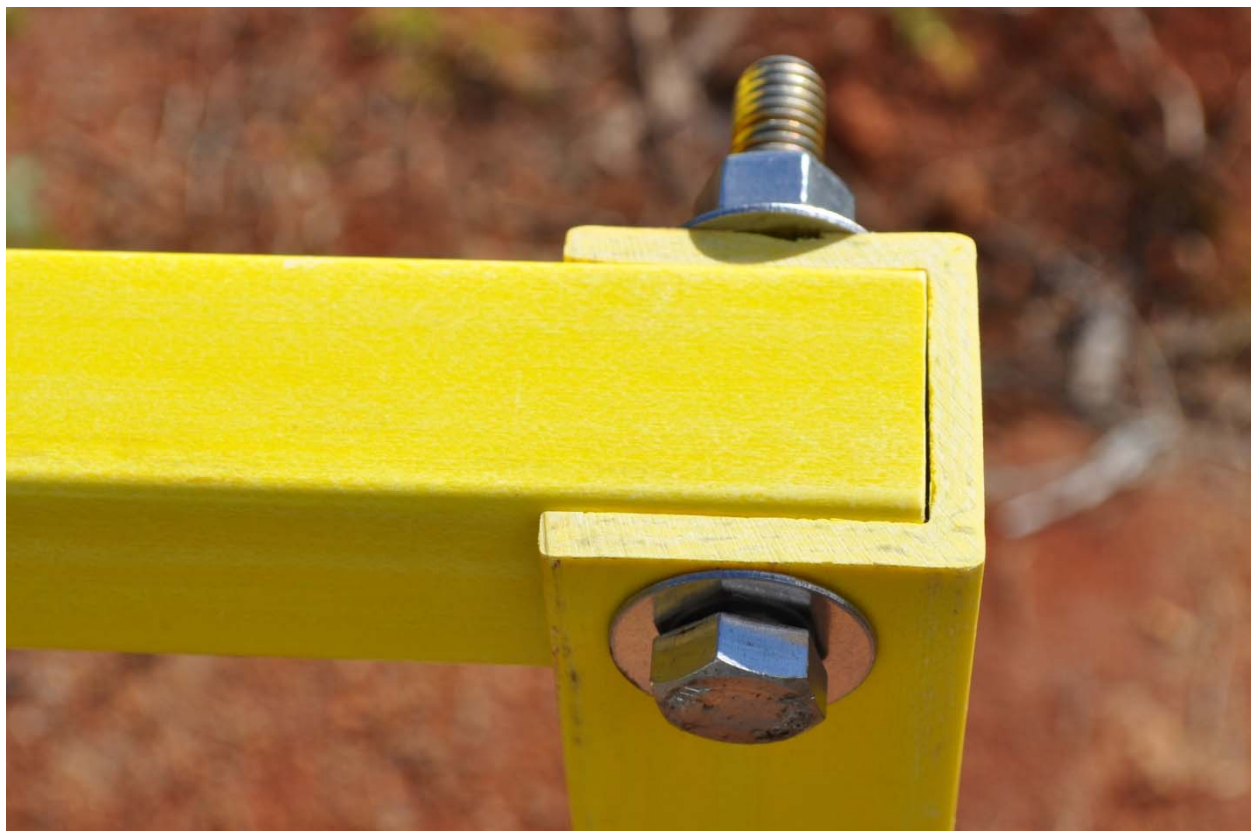
*Figure B78. Fabricated FRP Railing*

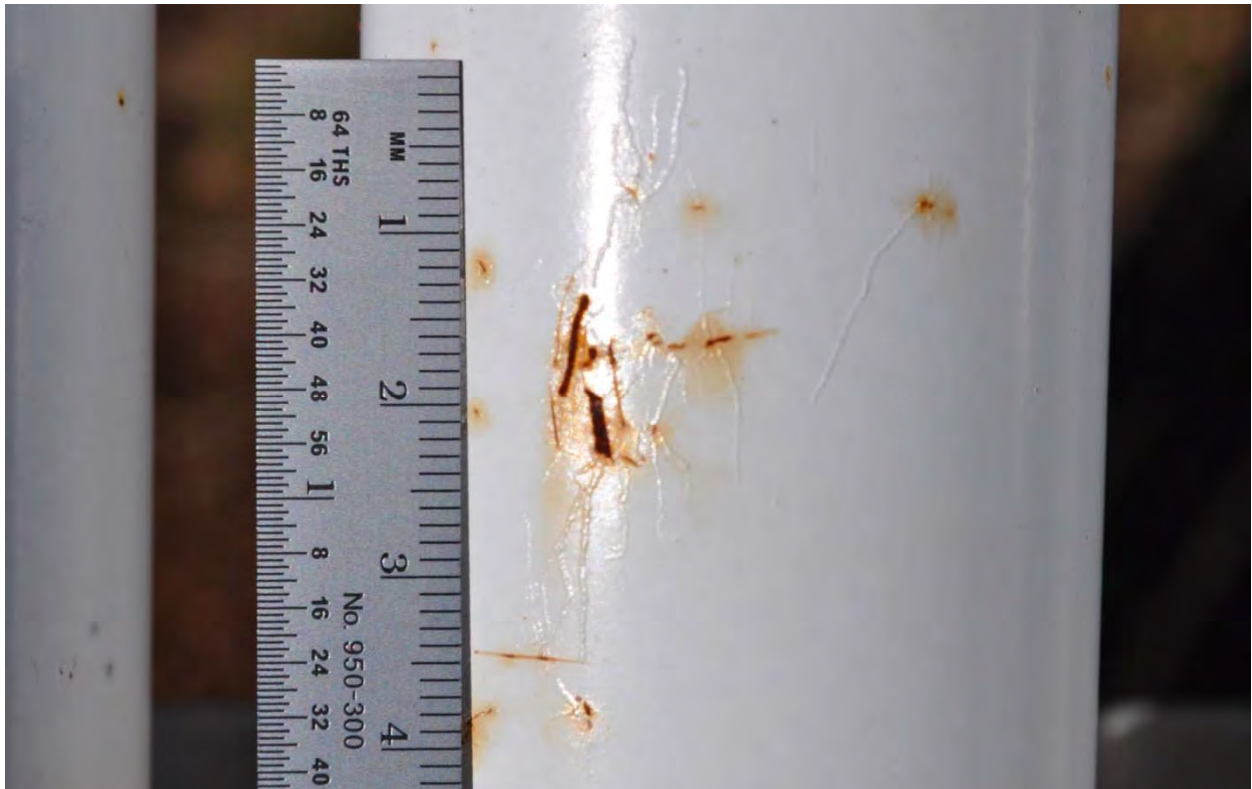
Aluminized Steel	20%	Oxidation	White oxidation of the zinc/AL coating 95% white corrosion on Galv. Hardware
	Fuse Bonded PVC Coated Galvanized	<5%	Rust	Minor rust has begun to form around cut ends and damaged areas
<b>Railing Coupons</b>	Stainless Steel	80%	Oxidation	Surface oxidation has discolored the material.
	Aluminum	<5%	Pitting	Pitting has begun in areas where the anodize may have been damaged
	Coated Steel	10%	Rust	Rust has begun to form where the coating has failed. Discoloring of the coating due to the rust.
	FRP	25%	UV	Discoloring due to UV exposure on the face of the railing that faces the sun
<b>Fabricated Railing</b>	Stainless Steel	50%	Oxidation	Surface oxidation has discolored the material. T-fittings show 90% surface corrosion likely due to lack of passivation.
	Aluminum	<5%	Pitting	Pitting has begun in areas where the anodize may have been damaged
	Coated Steel	10%	Rust	Rusting areas have spread larger causing blistering under the coating.

Figure B79. Coated Steel Coupon
